## REPAIRS TO PLYMOUTH ROCK PILGRIM MEMORIAL STATE PARK, PLYMOUTH

**State of Massachusetts Department of Conservation & Recreation (DCR)**

**Dates of Performance: 06/01/2017-06/13/2017**

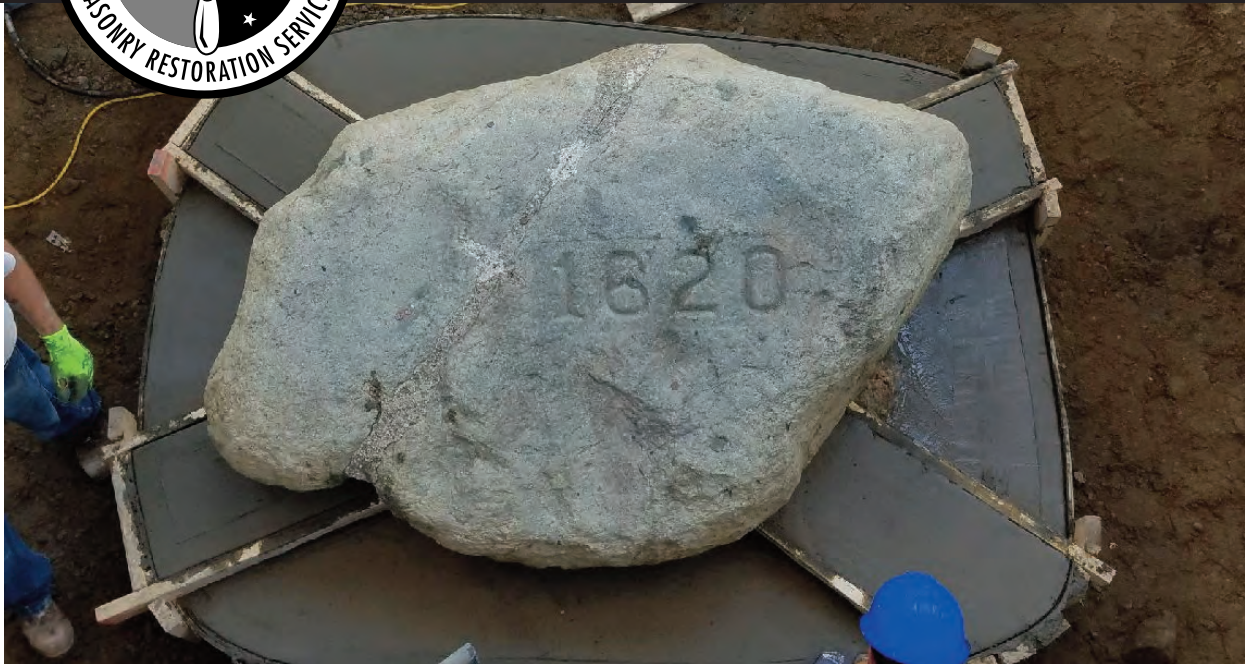
Plymouth Rock, a symbolic national icon is set above a stone base and supported by a combination of shim stones and four concrete "haunches" extending up from a concrete bumper that surrounds the stone base. The actual stone consists of two separate fragments that are joined with two brass cramp anchors. The gap between the two fragments is filled with mortar. The mortar was deteriorating at the base of the rock causing the fragments to separate. Stone & Lime Masonry Restoration Services was brought in to assist Ivan Myjer of Building & Monument Conservation (<http://www.ivanmyjerbmc.com/>) with the removal of 100% of the existing mortar between the fragments, re-point the joint between the fragments, remove the existing concrete bumper and haunches, and install new concrete bumper and granite haunches to support the rock fragments. This work was completed within a very tight timeframe, prior to tourist season, while battling the tide that rises and submerges the monument as the tide rises each day.
