PILGRIM MEMORIAL STATE PARK PLYMOUTH, MA REPAIRS TO PLYMOUTH ROCK

remove existing mortar; repoint joints; remove existing concrete bumper and haunches; install new concrete bumper and granite haunches

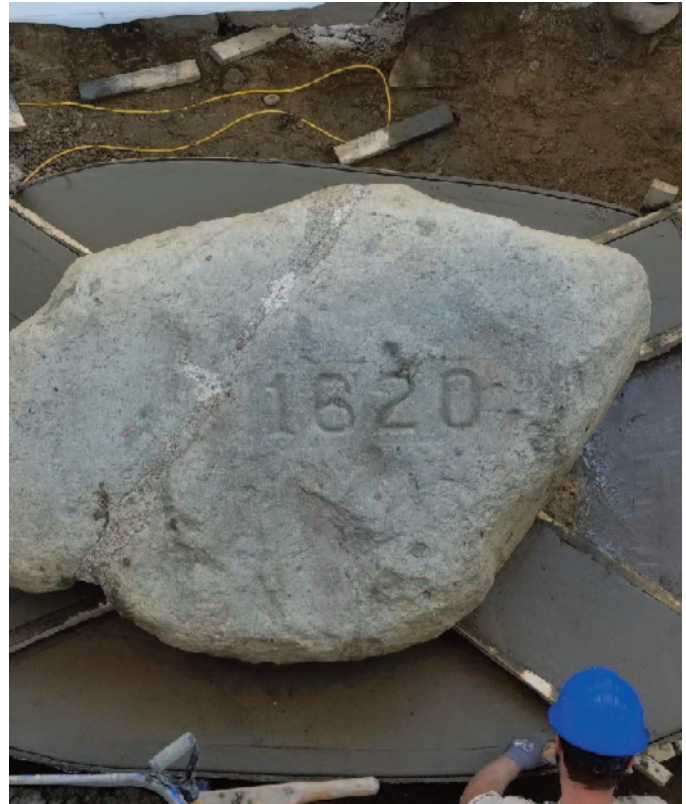
Plymouth Rock, a symbolic national icon, is set above a stone base and supported by a combination of shim stones and four concrete "haunches" extending up from a concrete bumper surrounding the stone base. The actual stone consists of two separate fragments joined with two brass cramp anchors. The gap between the two fragments is filled with mortar. The mortar was deteriorating at the base of the rock, causing the fragments to separate. Stone & Lime Masonry Restoration Services was contracted to assist Ivan Myjer of Building & Monument Conservation (<http://www.ivanmyjerbmc.com>) with the removal of 100% of the existing mortar between the fragments, re-point the joint between the fragments, remove the existing concrete bumper and haunches, and install new concrete bumper and granite haunches to support the rock fragments. This work was completed within a very tight timeframe, prior to tourist season, while battling the tide that rises and submerges the monument as the tide rises each day.
