REPAIRS TO PLYMOUTH ROCK PILGRIM MEMORIAL STATE PARK PLYMOUTH, MA

SCOPE OF WORK:

Remove existing mortar; repoint joints; remove existing concrete bumper and haunches; install new concrete bumper and granite haunches.

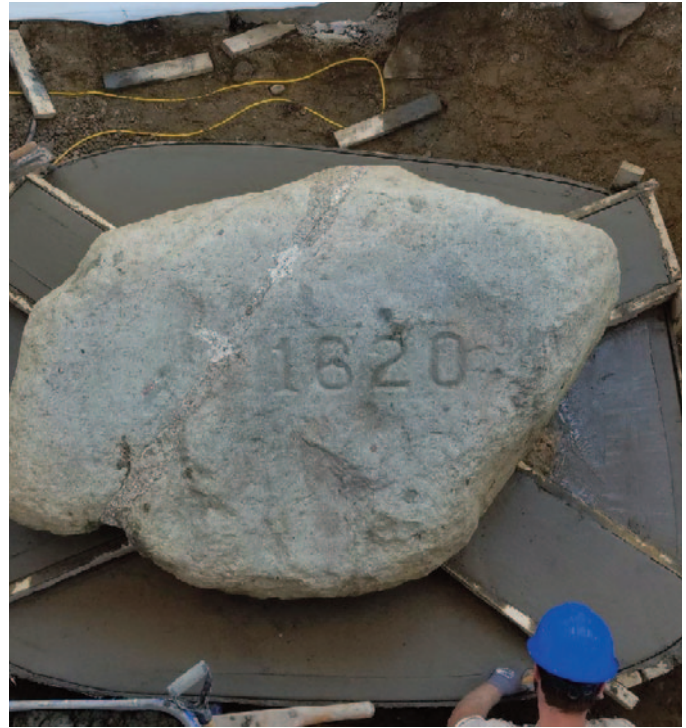
Plymouth Rock, a symbolic national icon, is set above a stone base and supported by a combination of shim stones and four concrete haunches extending up from a concrete bumper surrounding the stone base. The actual stone consists of two separate fragments joined with two brass cramp anchors. The gap between the two fragments is filled with mortar. The mortar was deteriorating at the base of the rock, causing the fragments to separate. Stone & Lime Masonry Restoration Services was contracted to assist Ivan Myjer of Building & Monument Conservation (<http://www.ivanmyjerbmc.com>) with the removal of 100% of the existing mortar between the fragments, repoint the joint between the fragments, remove the existing concrete bumper and haunches, and install new concrete bumper and granite haunches to support the rock fragments. This work was completed within a very tight timeframe, prior to tourist season, while battling the tide that rises and submerges the monument each day.
