REPAIRS TO PLYMOUTH ROCK PILGRIM MEMORIAL STATE PARK PLYMOUTH, MA

Remove existing mortar; repoint joints; remove existing concrete bumper and haunches; install new concrete bumper and granite haunches

PROJECT SUMMARY

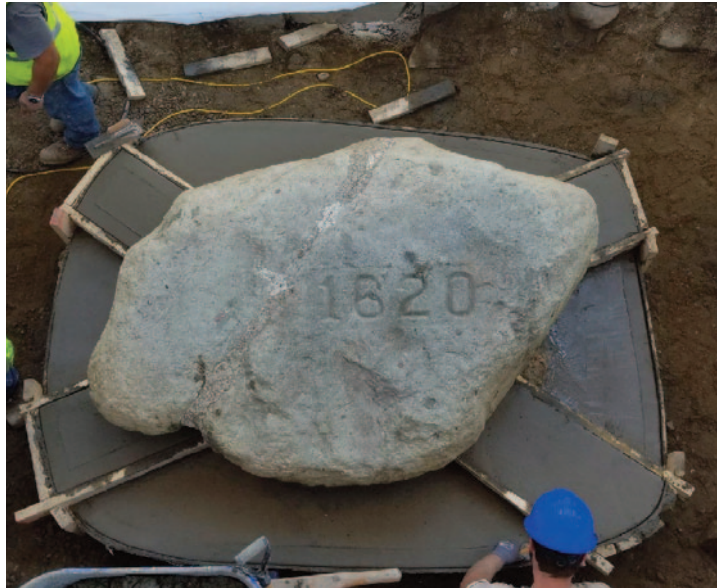
Plymouth Rock, a symbolic national icon, is set above a stone base and supported by a combination of shimstones and four concrete haunches extending up from a concrete bumper surrounding the stone base. The actual stone consists of two separate fragments joined with two brass cramp anchors. The gap between the two fragments is filled with mortar. The mortar was deteriorating at the base of the rock, causing the fragments to separate. Stone & Lime Masonry Restoration Services was contracted to assist Ivan Myjer of Building & Monument Conservation (<http://www.ivanmyjerbmc.com>) with the removal of 100% of the existing mortar between the fragments, repoint the joint between the fragments, remove the existing concrete bumper and haunches, and install new concrete bumper and granite haunches to support the rock fragments. This work was completed within a very tight timeframe, prior to tourist season, while battling the tide that rises and submerges the monument each day.
