FORT JEFFERSON EMERGENCY SHORING OF FRONT 3 DRY TORTUGAS NATIONAL PARK, FL

Repair portions of brick masonry scarp wall; remove iron components of shutter assembly; partial reconstruction of shutter assembly; reconstruction of embrasure openings; repair and repoint scarp wall using natural cement

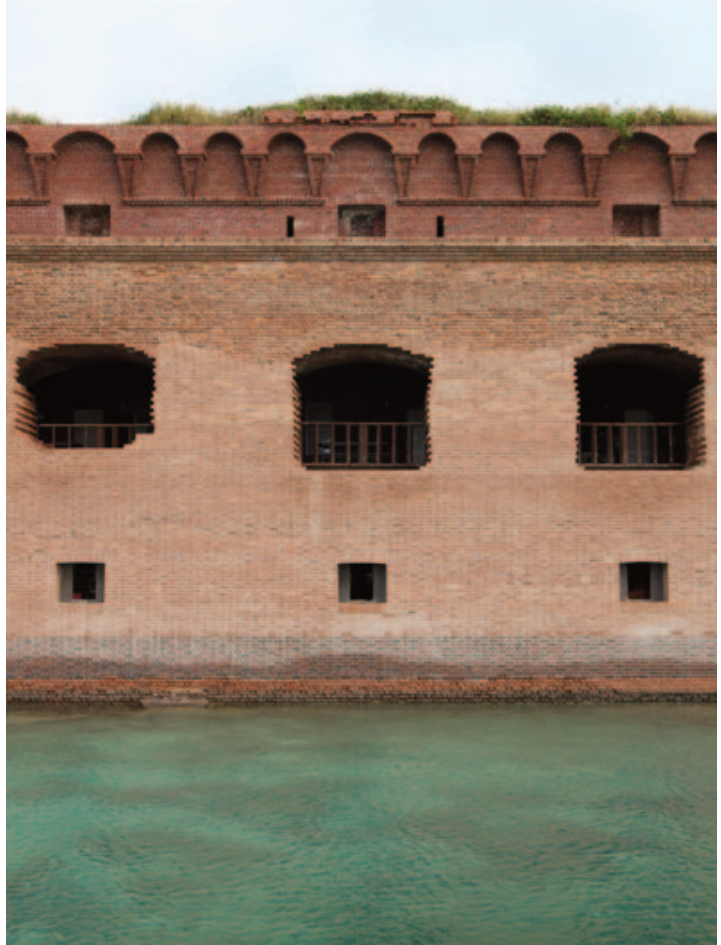
Stone & Lime Historic Restoration Services was contracted to repair portions of the brick masonry scarp wall along Front 3 at Fort Jefferson. The scarp wall masonry was severely deteriorated and, in many areas, had collapsed into the moat due to the corrosion and expansion of internal iron elements. The scope of work included the removal of iron components of the historic Totten shutter assembly; partial reconstruction of the shutter assembly using cast concrete replacement components; reconstruction of the embrasure openings; and the repair and repointing of the scarp wall using natural cement, from the magistral line to the top of the string course.
